Phase I Environmental Site Assessment

Oldenburg Industrial Site

Washington, Franklin County, Missouri

July 1, 2025 | Terracon Project No. 15257202

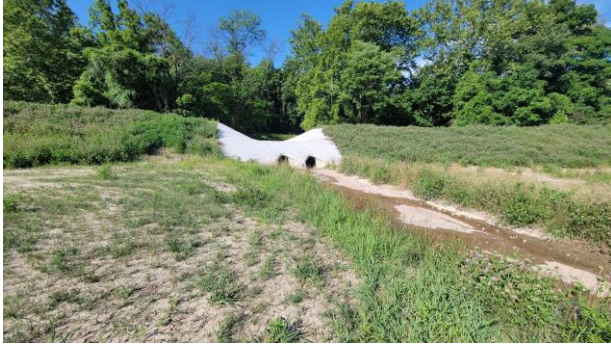
<p>Photo 11 - Detention pond drainage in the southeastern portion of the site, facing north</p>	<p>Photo 12 - Detention pond drainage in the southeastern portion of the site, facing south</p>

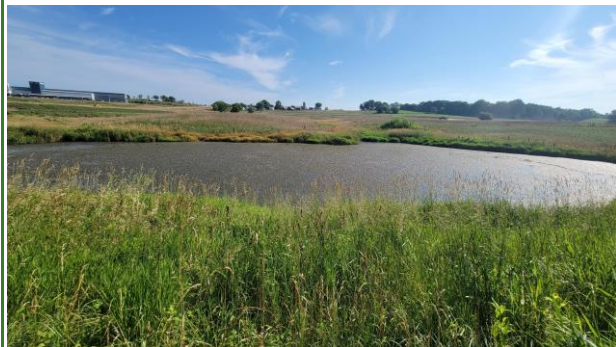
Photo 13 - Pond in the southeast corner of the site

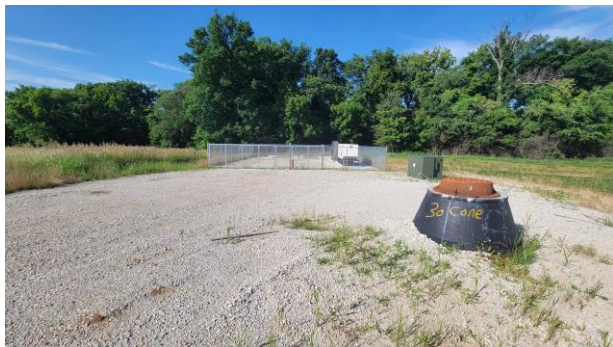
A sanitary sewer lift station was observed in the southeast corner of the site. The lift station was surrounded by metal wire fencing and appeared to be in good condition. According to Mr. Griesheimer, the lift station was installed approximately three years ago. Indications of staining or releases were not observed.

Photo 14 - Sanitary sewer lift station in the southeast corner of the site

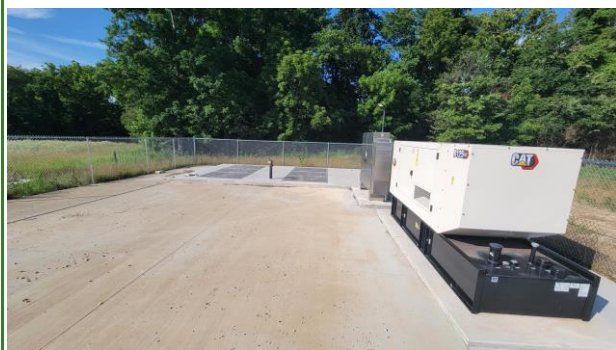
A natural gas emergency generator was observed in the southeast corner of the site, associated with the sanitary sewer lift station. According to Mr. Aaron Griesheimer, the representative of the site owner, the lift station was installed approximately three years ago. The generator appeared to be in good condition. Indications of staining or releases were not observed.

Photo 15 - Sanitary sewer lift station with natural gas emergency generator

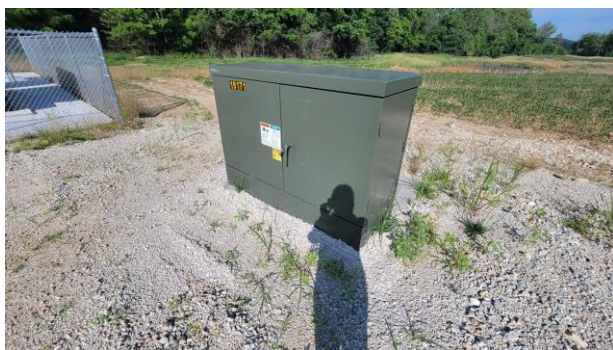
A pad-mounted transformer was observed in the southeast corner of the site, associated with the sanitary sewer lift station. The transformer appeared to be in good condition with no damage or leaking observed. However, no information regarding PCB content of the transformer fluids was observed. Some transformers contain mineral oil which may contain PCBs.

Ameren maintains responsibility for the transformers, and if the transformers were "PCB contaminated," Ameren is not required to replace the transformer fluids until a release is identified. However, evidence of current or prior release was not observed in the vicinity of the electrical equipment during the site reconnaissance.

Photo 16 - Pad-mounted transformer associated with the sanitary sewer lift station

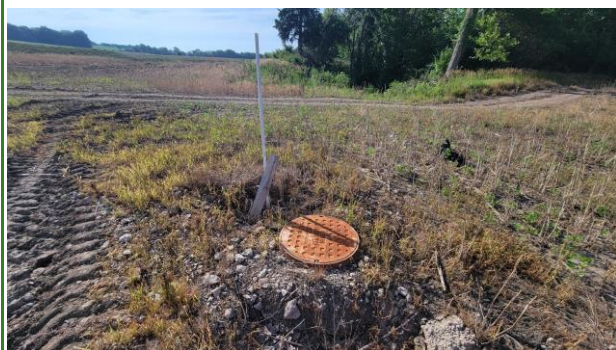
Terracon observed sanitary sewer system manhole covers in the northeastern portion of the site. The sanitary sewer system appeared to be constructed in preparation for the future use of the site. The areas of the sanitary sewer system that were visible appeared to be in good condition. Indications of staining or releases were not observed.

Photo 17 - Sanitary sewer system observed in the northeastern portion of the site

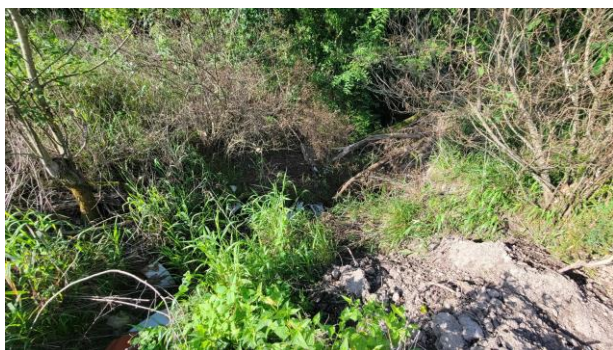
Debris consisting of general plastic debris and plywood was observed in a drainage ditch on the southwestern side of the site. The debris materials did not appear to be hazardous in nature. Significant staining, noxious odors, or hazardous waste material was not observed in the vicinity of the debris.

Photo 18 - Debris in drainage ditch along southwest portion of the site

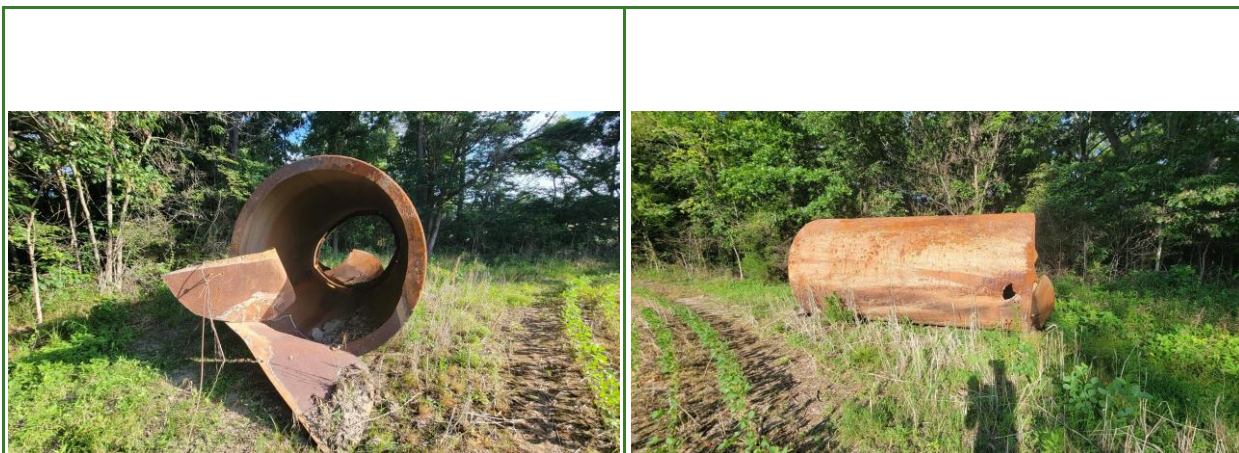
A metal pipe was observed in the northwestern corner of the site. According to Mr. Griesheimer, the pipe was used as a culvert and was pulled out of the ground by the previous landowner. Significant staining, noxious odors, or hazardous waste material was not observed in the vicinity of the metal pipe.

Photo 19 - Metal pipe in the northwestern corner of the site

Photo 20 - Metal pipe in the northwestern corner of the site

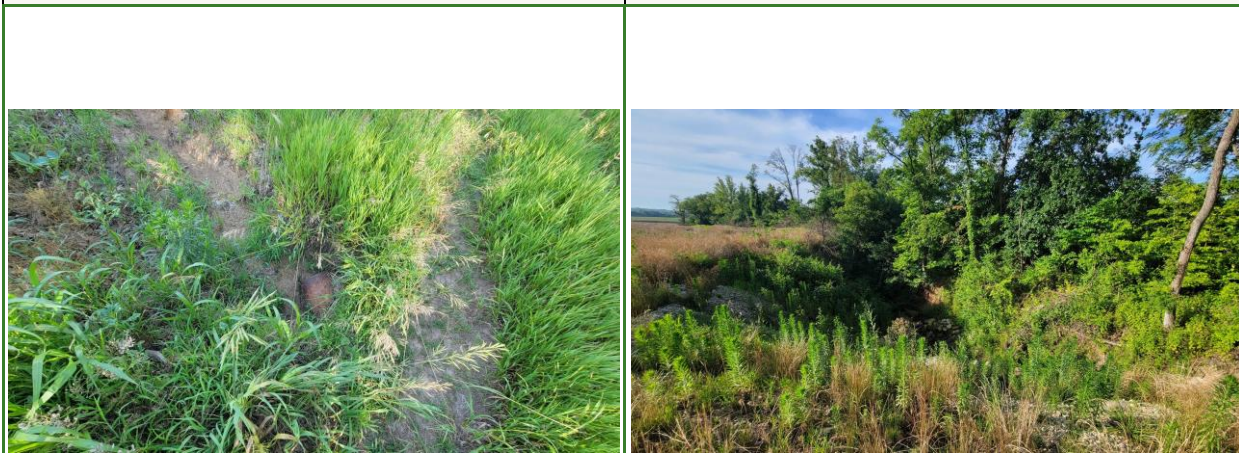
Terracon observed ponds in the southeastern and southwestern portion of the sites. Drainage ditches with culverts were observed in the northeastern corner of the site that joins an intermittent stream that extends generally north to southwest through the site. An additional intermittent stream was observed along the southern border of the site. A detention pond with drainage areas were observed in the southeastern portion of the site.

Photo 21 - Culverts in the northeastern corner of the site

Photo 22 - Intermittent stream along the northern portion of the site
